Experimental Testing of Reinforced Concrete Slabs Retrofitted with CFRP and Mechanical Anchors

G.L. Pezzola¹, L.K. Stewart¹

Abstract

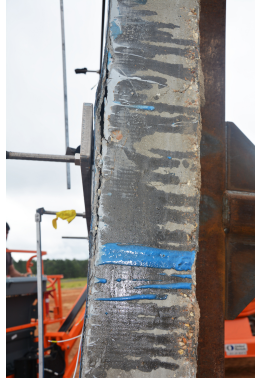
Both the FT1 and FT2 specimen exhibited damage in the concrete and CFRP. In the FT1 specimen, most of the concrete damage was located on the non-blast side of the specimen, with greater concrete damage located close to the location of the straps. There was also a significant amount of CFRP tearing located near the straps that spanned the width of the straps. This tearing was the greatest at the middle strap. Debonding occurred near the middle straps, similar to a previously reported failure mode, “plate-end debonding” [8], but this particular failure mode had never been reported

before this test series. A small layer of concrete and even aggregate were still attached to the CFRP, indicating that no adhesive failure occurred. Figure 6 is a post-test photo of the side of FT1, where the debonding and concrete failure near the middle strap can be seen.

Figure 6: Concrete failure and debonding in FT1.

In FT1, there were long cracks that were parallel to the height of the specimen, suggesting that the governing failure mode was similar to what has been classified as “plate-end debonding” [8]. Concrete cover separation and plate-end interfacial debonding (shown in Figure 8) are two more specific failure modes that can be classified as plate-end debonding failure modes. Plate-end debonding failures are not adhesive failures. These failures occur in the concrete, most likely due to high tensile or shear forces, and then can propagate as far as the steel reinforcement in the specimen and continue to move along the length of the slab, according to Teng et. al. [8]. Plate-end debonding failures are usually seen at the end of FRP plates due to the sudden change in stiffness at that point. This failure, however, occurred at and around the steel straps. Long cracks parallel to the steel reinforcement were observed to begin and terminate near the steel straps, suggesting that the sudden change in stiffness of the specimen at those points resulted in a failure similar to plate-end debonding. The failure mode observed in FT1 was a new failure more that had never been reported before this test series [7]. This new failure mechanism is therefore classified as a “strap-induced debonding” failure mode, where the presence of the steel strap that spans the width of the specimen causes the abrupt change in stiffness that drives this failure mode.

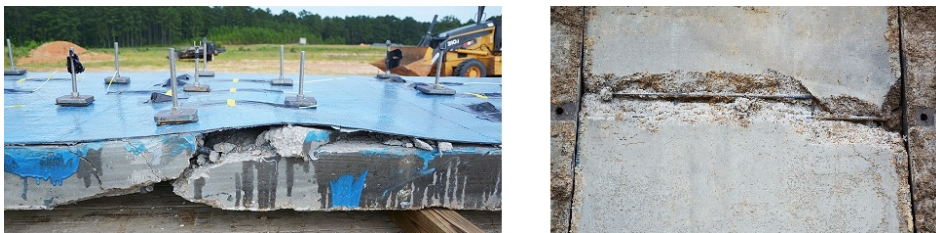
In the FT2 specimen, similar to the FT1 specimen, most of the concrete damage occurred on the non-blast side of the specimen, but concrete crushing on the compressive side was also observed. Large flexural and flexural shear cracks were observed in the specimen. The location at which these cracks widened is the point at which debonding initiated in the retrofit. This debonding failure mode has been previously classified as “intermedi-

ate flexural and flexural shear crack-induced debonding” [8]. Despite the amount of damage in the FT2 specimen, widespread delamination was prevented as the smaller, more evenly distributed anchors allowed for a more even distribution of stresses. Small tears in the CFRP were observed near the anchors, but were not long in length, which indicates that using smaller anchors allows for less stress localizations to be induced in the specimen, as opposed to straps that span the width which caused much longer tearing in the CFRP. Figure 7 shows two post-test photos of FT2, major flexural shear cracks and debonding (left), and concrete crushing (right).

Figure 7: Intermediate crack-induced debonding (left) and concrete crushing (right) in the FT2 field test specimen.

In FT2 large flexural and flexural-shear cracks were formed, indicating that the failure mode in this slab was “intermediate flexural and flexural-shear crack-induced interfacial debonding”, mixed with a compressive failure mode in the concrete due to the large cracks in the front face of the specimen. Intermediate flexural and flexural-shear crack-induced interfacial debonding occurs when a flexural or flexural-shear crack occurs far from a plate end and initiates the point of debonding of the CFRP and concrete. This debonding then propagates away from the initial point. This failure

epoxy adhesive anchors performed well and it is recommended that future testing on these easy to install, cost effective anchors should be conducted. It was found that using smaller anchors that are more evenly spaced allow for a more even distribution of stresses in the retrofit system, and can prevent widespread delamination. Therefore, it is recommended that smaller, more evenly spaced anchor systems be used instead of a strap system for CFRP retrofits.

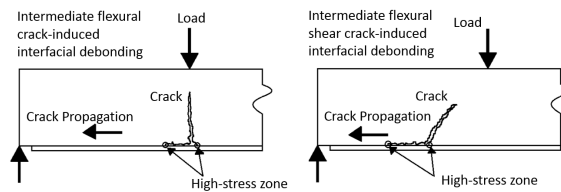
does not occur in the adhesive, but initiates in the concrete. A schematic of this failure is shown in Figure 9.

Figure 9: Schematic of intermediate flexural and flexural-shear crack-induced interfacial debonding.
