Experimental Testing of Reinforced Concrete Slabs Retrofitted with CFRP and Mechanical Anchors

G.L. Pezzola¹, L.K. Stewart¹

Abstract

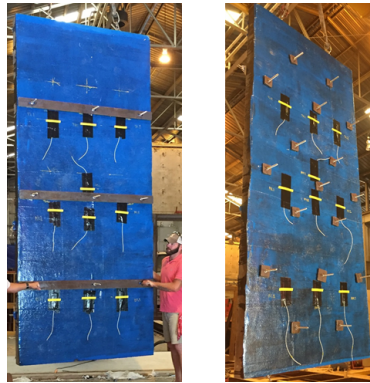
Figure 1: Finished strap anchorage retrofit (FT1 - left) and finished plate anchorage retrofit (FT2 - right).

It should be noted that the installation of the steel strap anchorage system was not easy. It was anticipated that there would be some difficulty installing straps over post-construction installed epoxy anchors, so slots were designed into the steel straps to help the installation process. Even with slots for every hole, and very carefully measured and drilled holes for the epoxy anchors, the steel straps did not go on easily. A large mallet had to be used to get all three straps on the specimen.
